Rexarc Acetylene Plant Case Study

Problem identification, solution development, and maintenance tips.

The following slides are from a recent acetylene plant audit completed by Rexarc technical personnel.

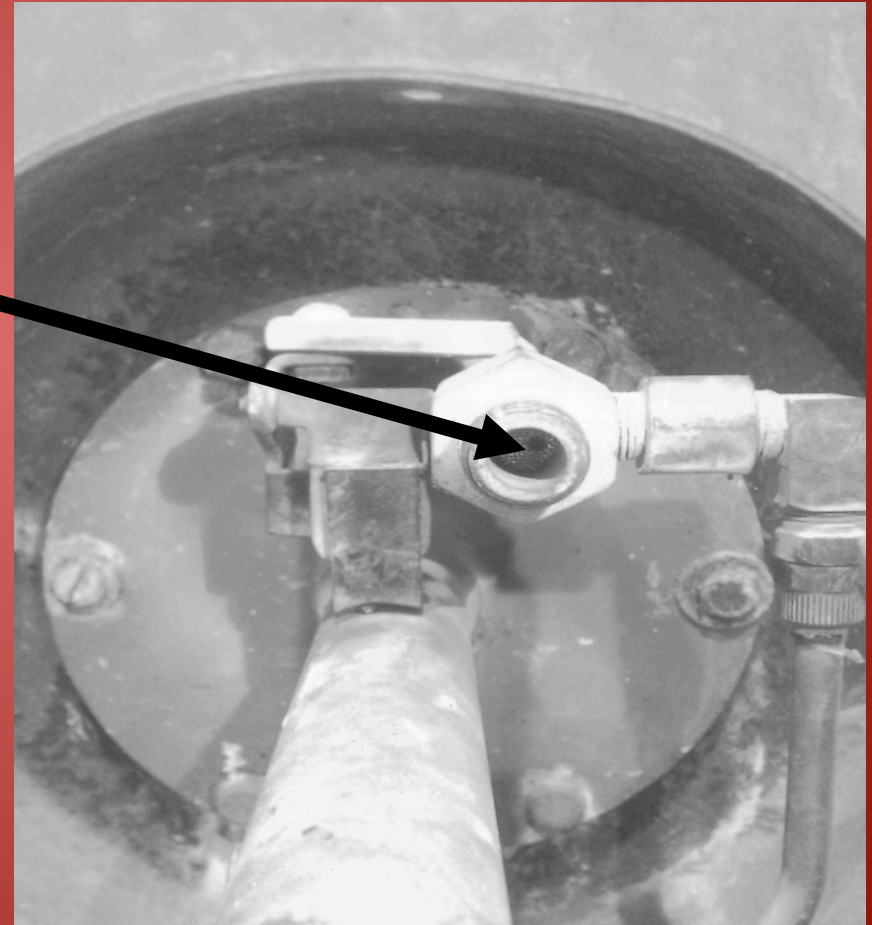
Hole has been drilled into high water alarm eliminating the alarm

A major cause of the high level alarm on old plants is leaks in the aluminum tubing from corrosion or wear. Replacing all of the tubing from the generator controls to the motor control panel with stainless steel tubing will remedy this problem of leaks.

New restriction tee is needed

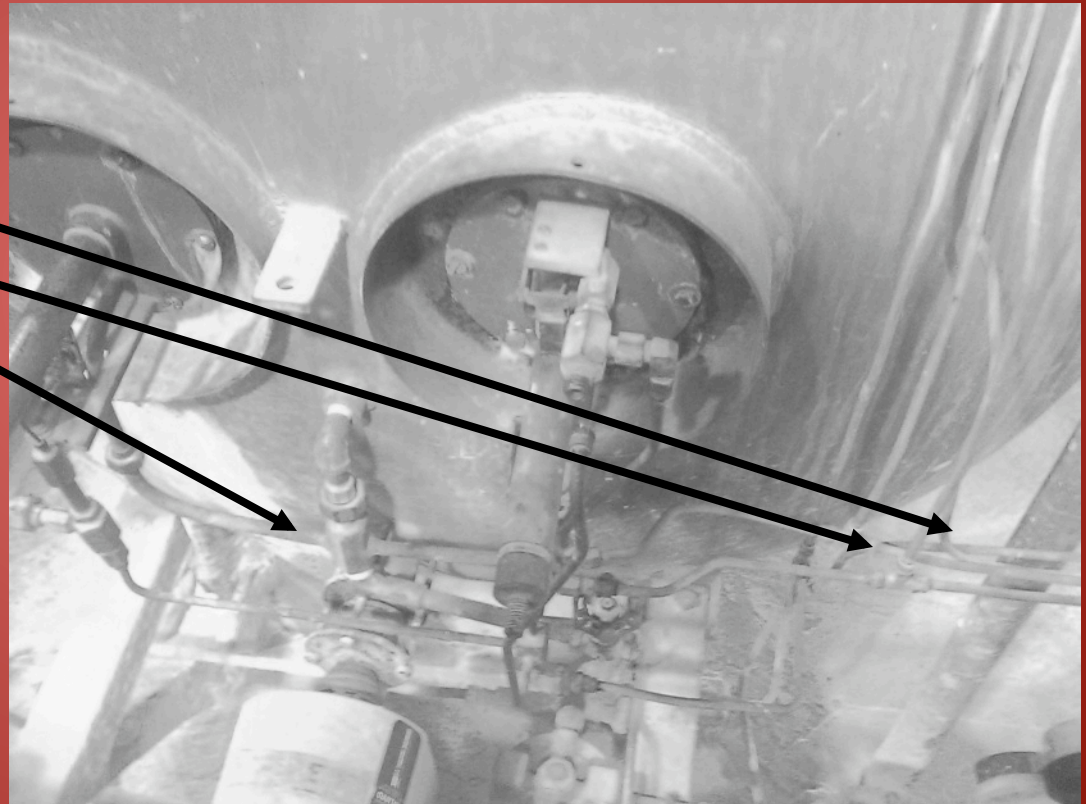
The air fitting connections have leaks and the restrictors have been drilled out to compensate for this problem

Replace the aluminum tubing with $\frac{1}{4}$ " (.250) stainless steel tubing. All leaks in this tubing must be stopped for the controls to operate correctly

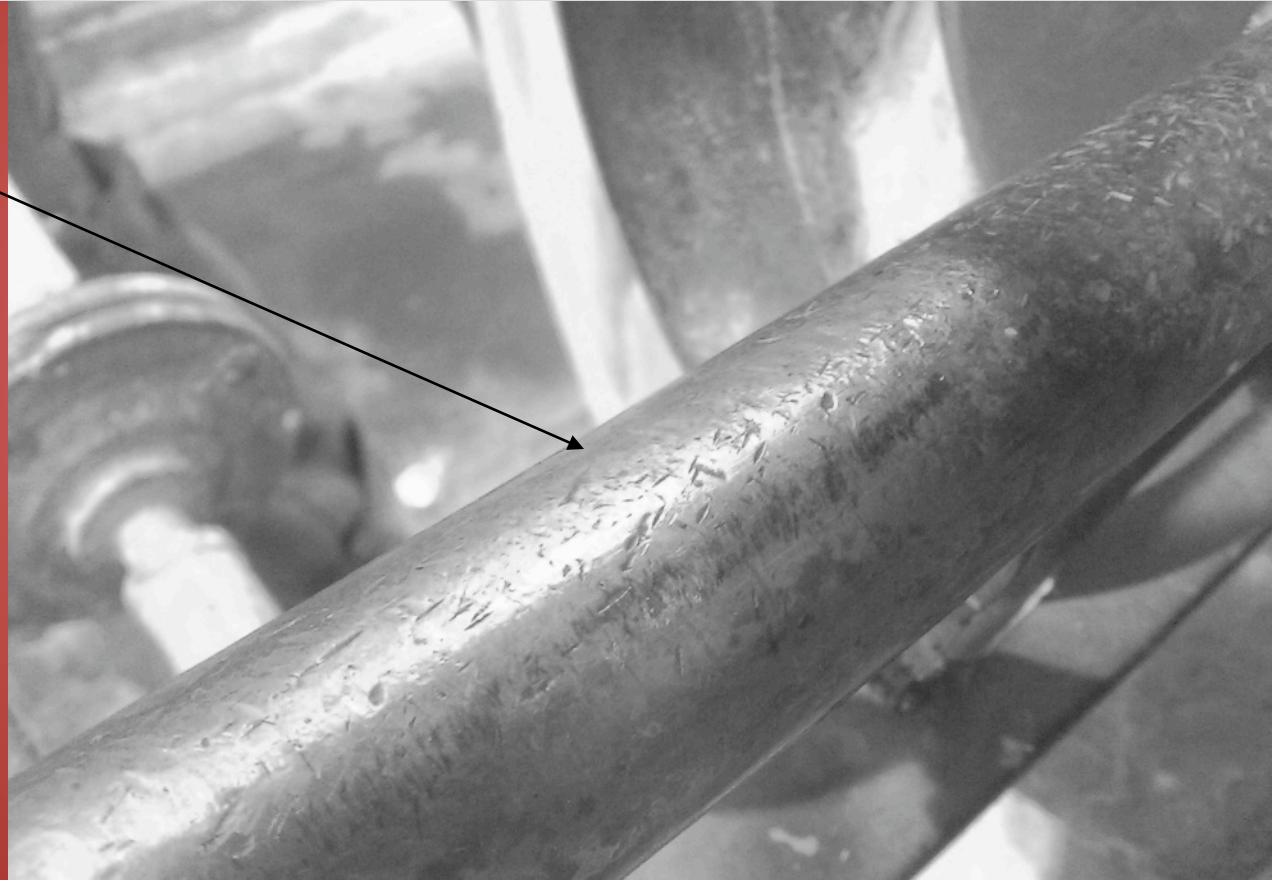
Control tube has been hit with a wrench multiple times to unstick movement

Replace complete control tube as it has been made oval due to being hit, now it is frozen

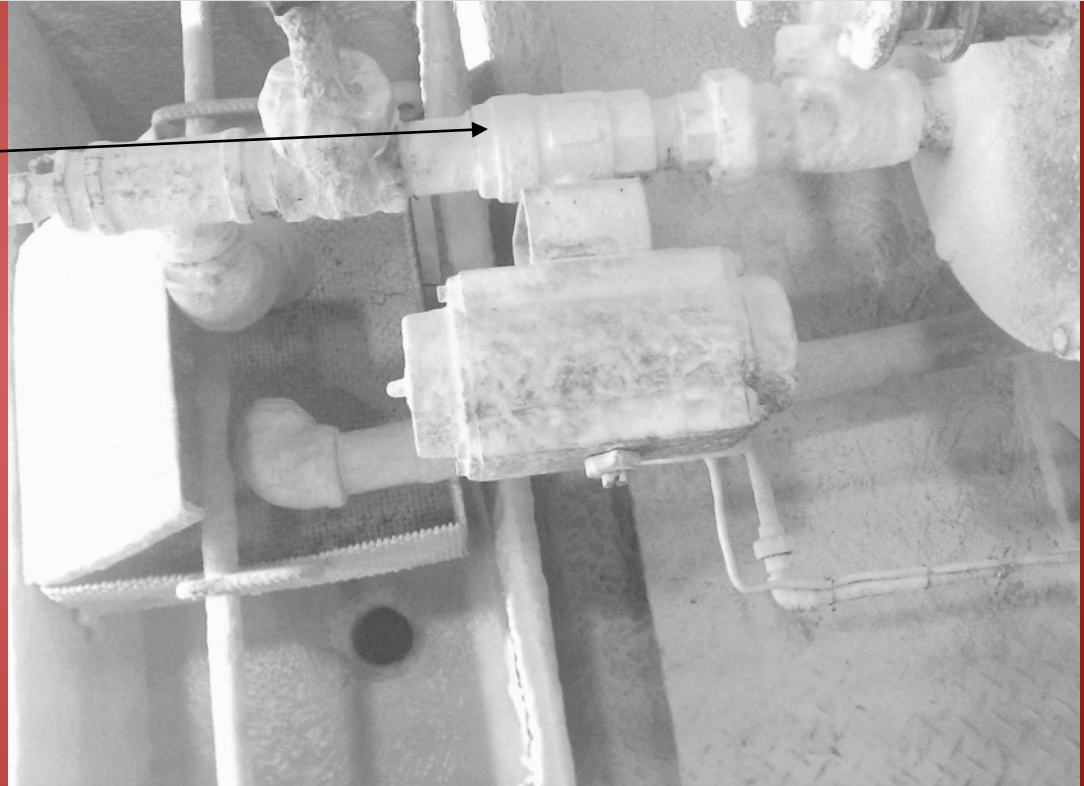
Generator drain valve has
a leak

Replace unit

Pilot valve should be replaced
at the same time

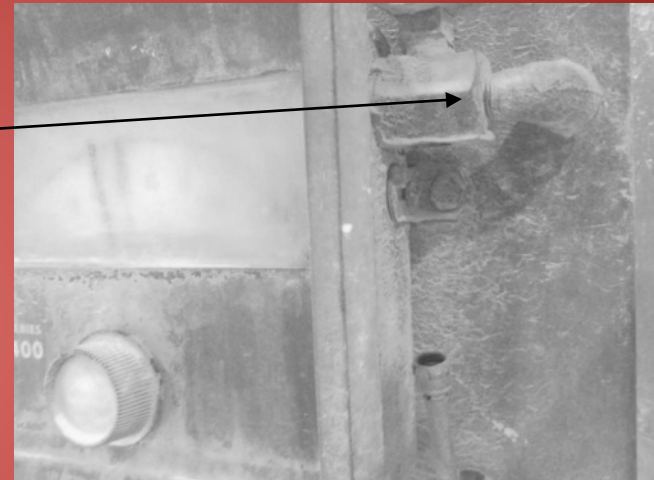
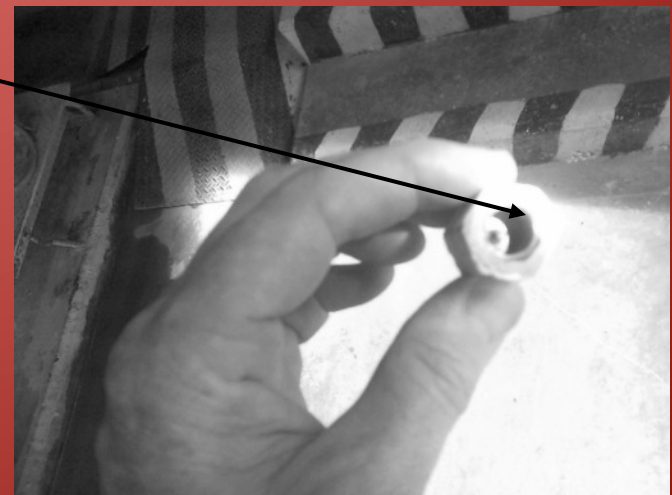
Water inlet instrument has been modified. Hole has been drilled in the snubber

With the hole in the snubber water is added at all times using more water than is needed and producing extra lime slurry.

New G snubber is needed

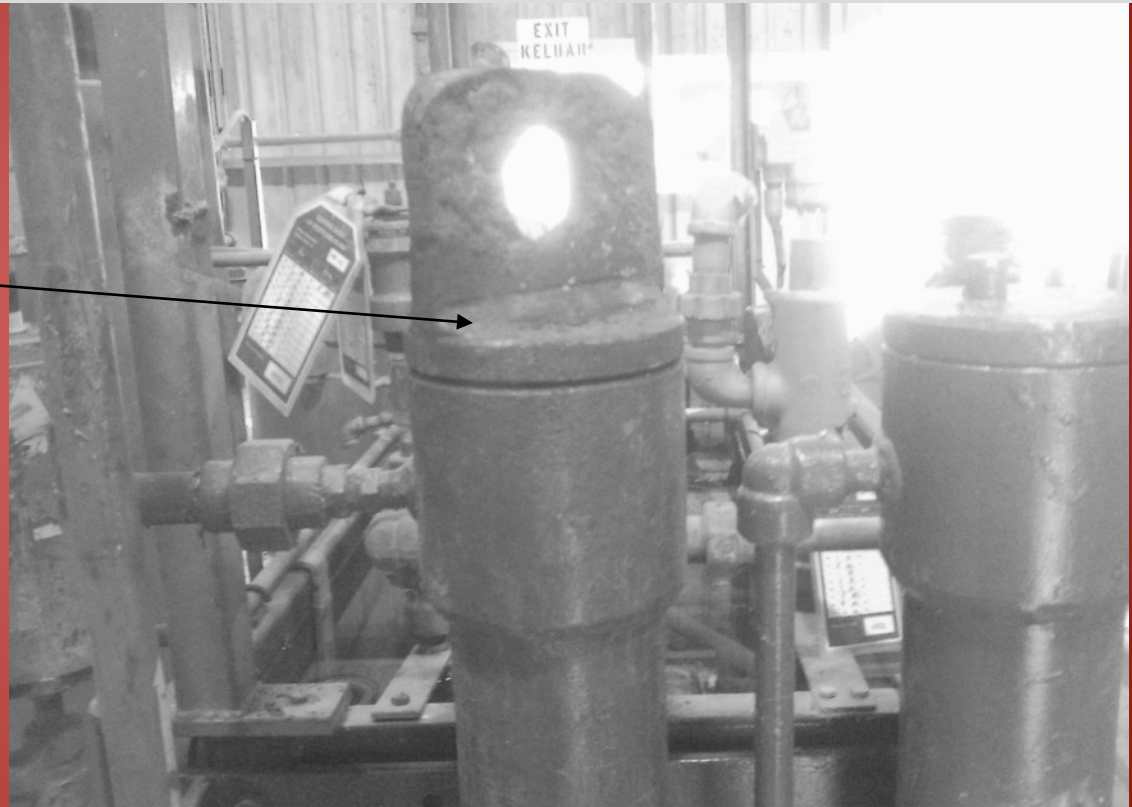
High pressure drier cannot be opened

Without the addition of calcium chloride daily, water will enter the acetylene cylinders.

Replacement of the set of driers is strongly recommended

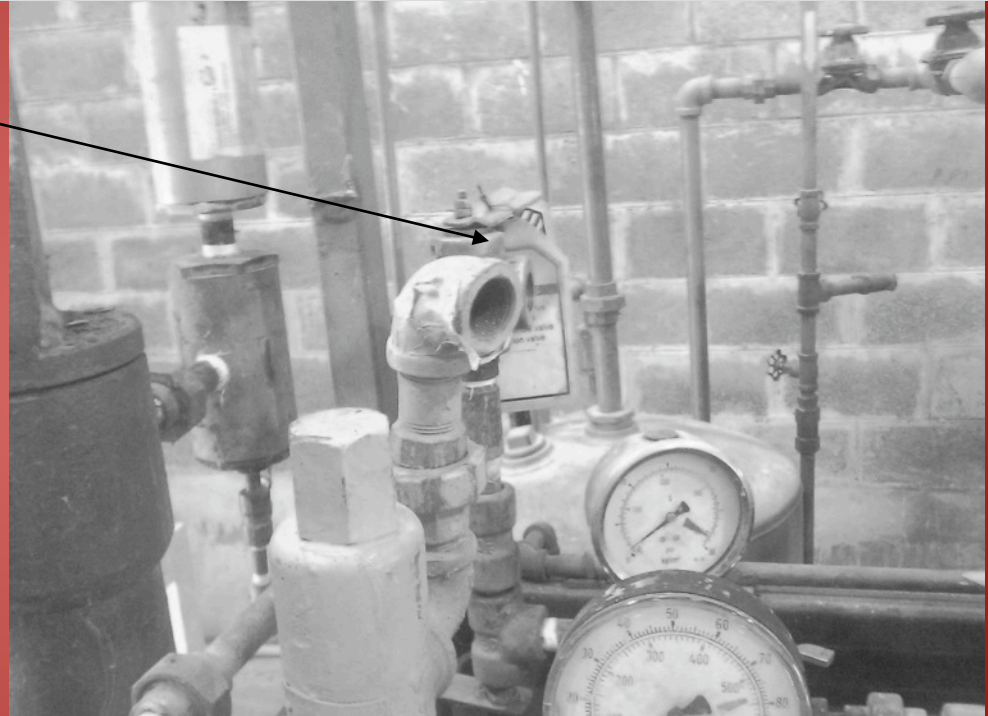
Vent piping from relief valves has been removed on the compressor

High pressure acetylene will be released into the generating room which could ignite from static electricity to start a fire.

Install vent piping

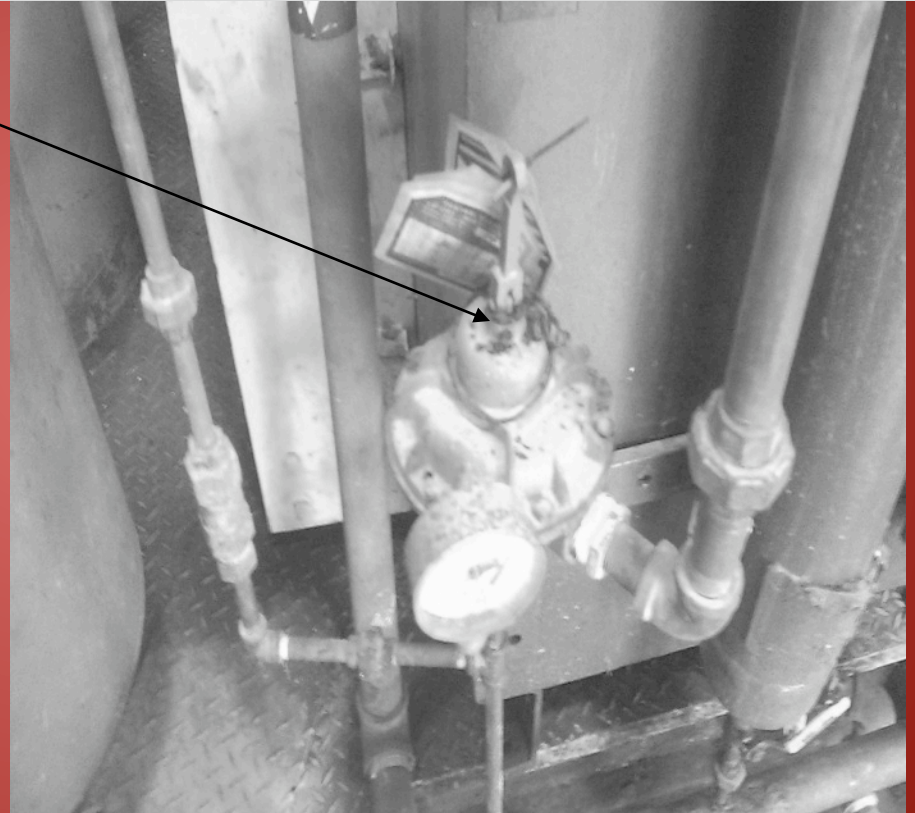
Relief valve is corroded badly
and does not work

This relief valve keeps high pressure
acetylene from entering the room.

The relief valve must be
replaced

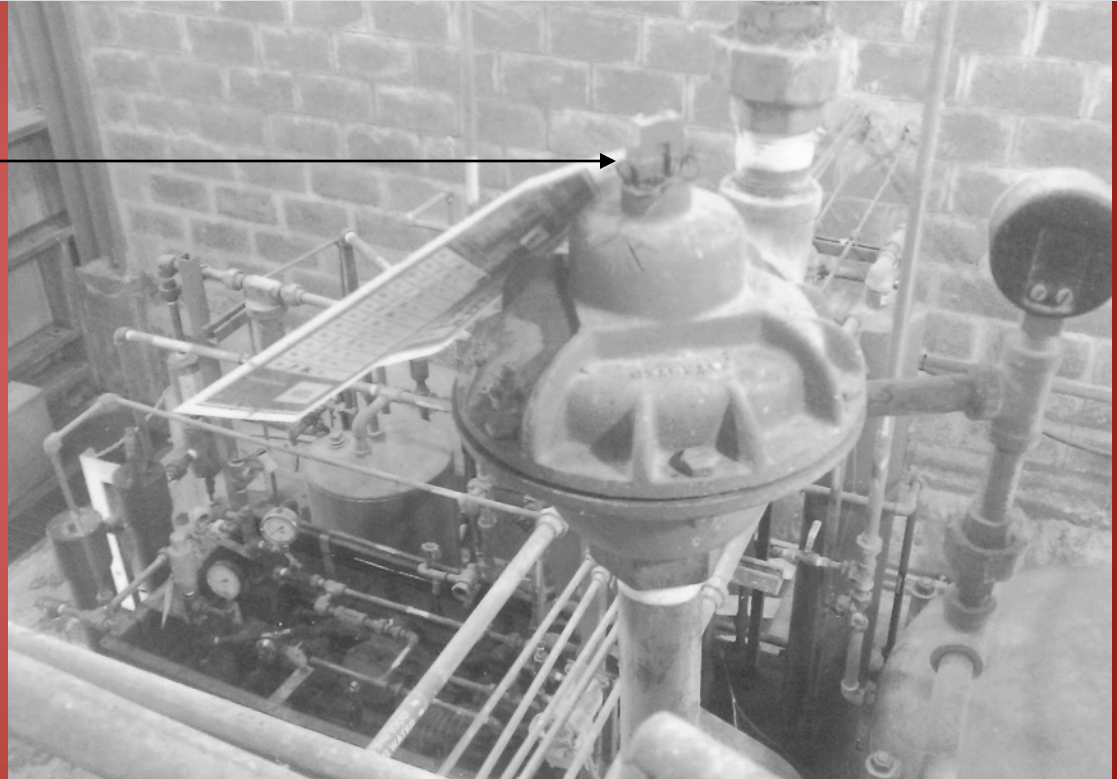
Handle is broken on the
flashback relief valve

Replace handle

Handle can be removed and
replaced without effecting the
pressure setting of the relief
valve.

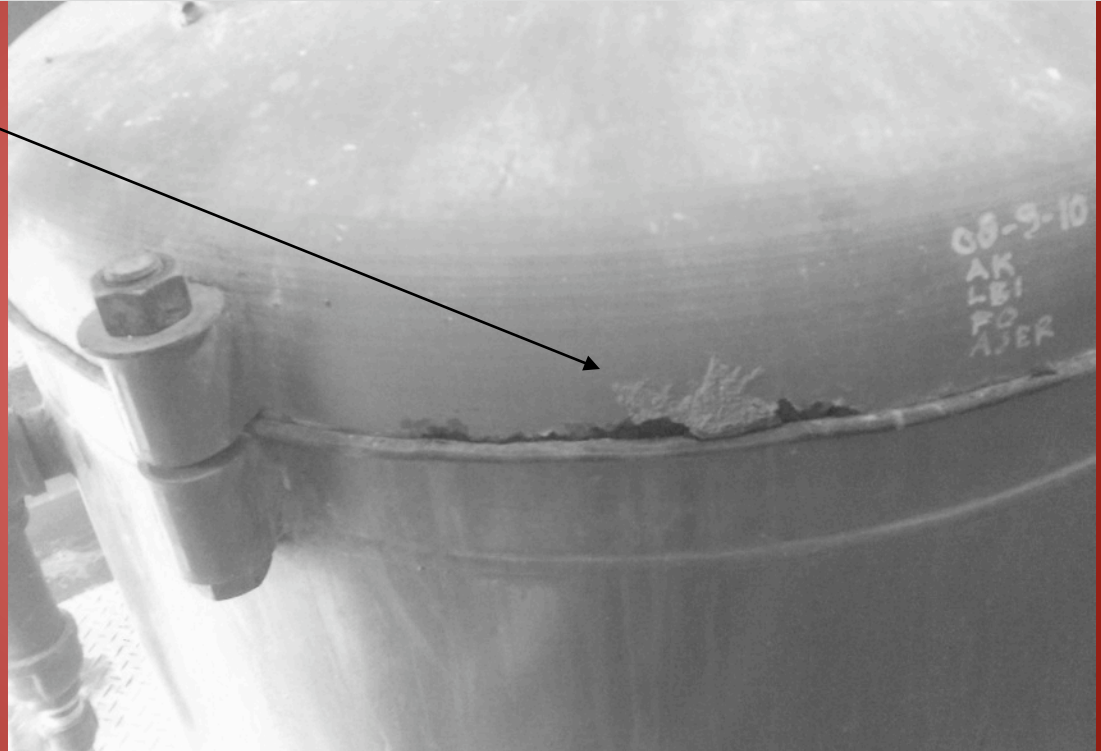
Problem Identified:
Corrosion on purifier

The corrosion needs to be removed and a anti-corrosion agent applied.

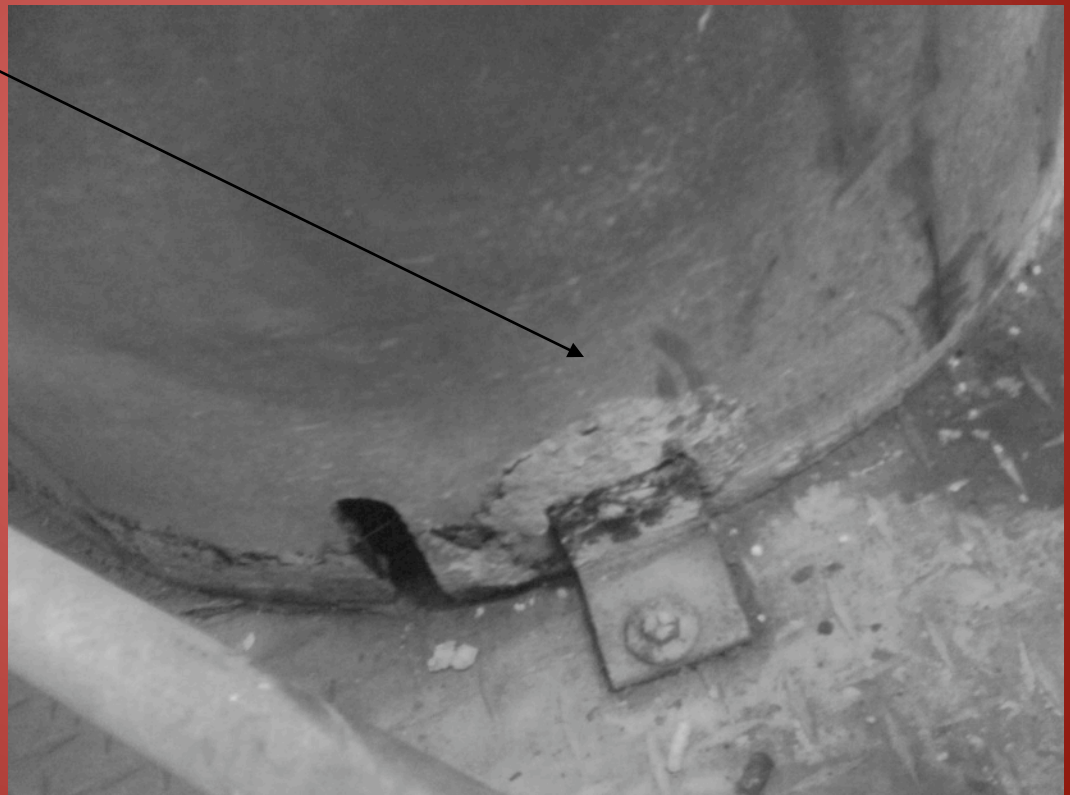
Corrosion at the base of
the medium pressure drier

The corrosion needs to be
removed and a anti-
corrosion primer and paint
used to protect the metal
from further corrosion.

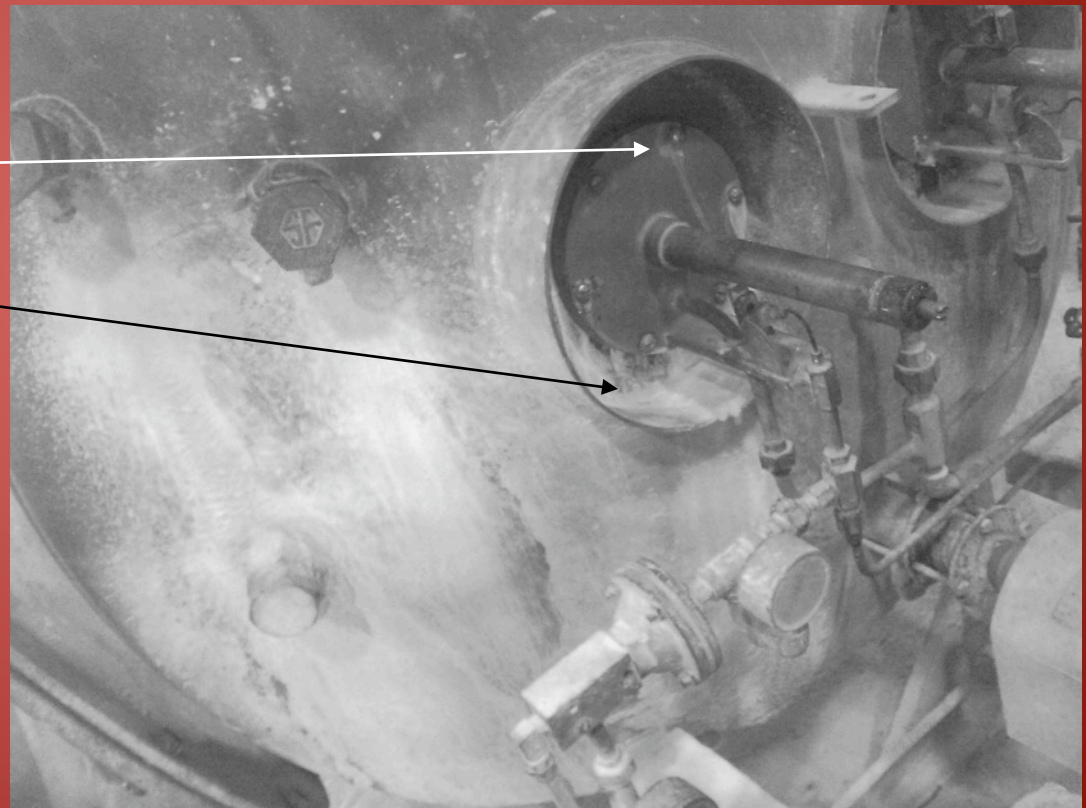
1. Acetylene leaking from the top of the control.
2. Lime slurry leaking from between the control unit and the generator

New diaphragm needed

When replacing unit make sure diaphragm is in good condition.
Use bolts, not screws, to mount the control.

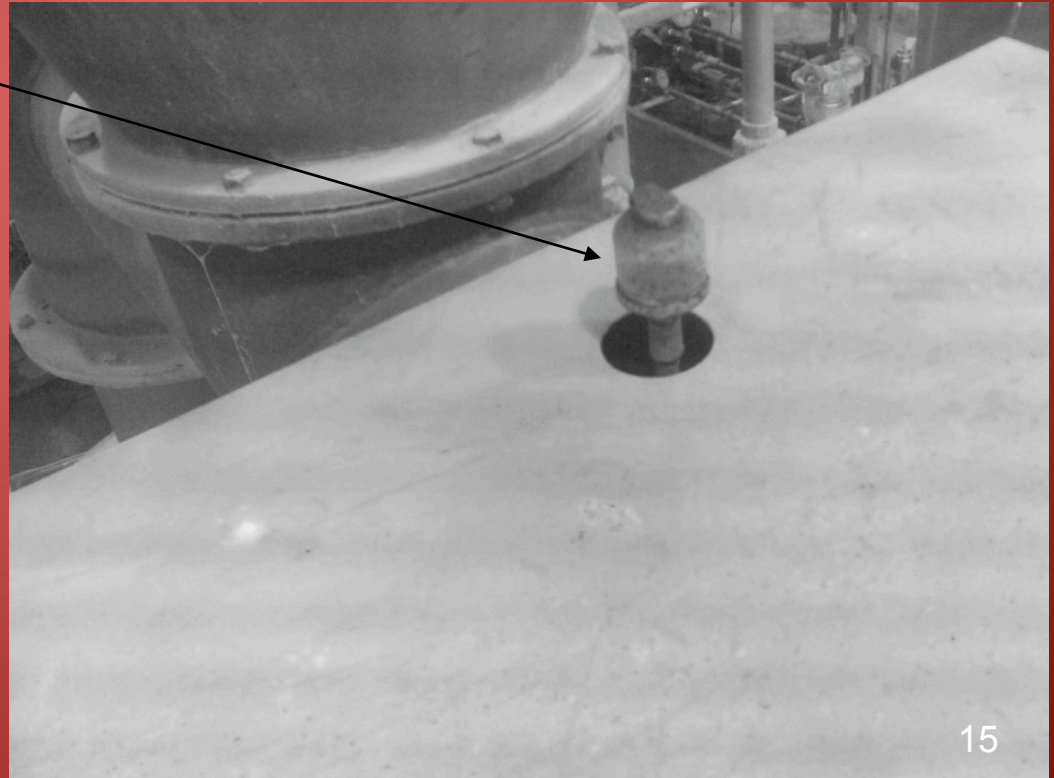
Empty oiler shows lack of proper maintenance

Fill oiler with proper oil

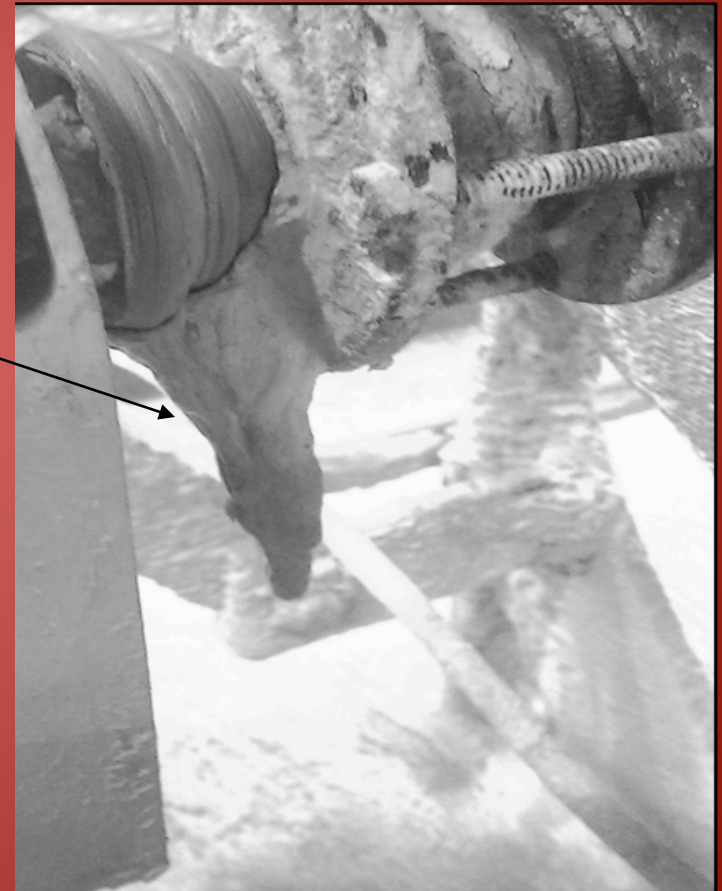
Lime slurry leaking from the agitator shaft

Leaking lime slurry accelerates shaft wear causing premature failure. Change the packing and lubricate the shafts with grease several times daily.

Keep agitator shafts lubricated

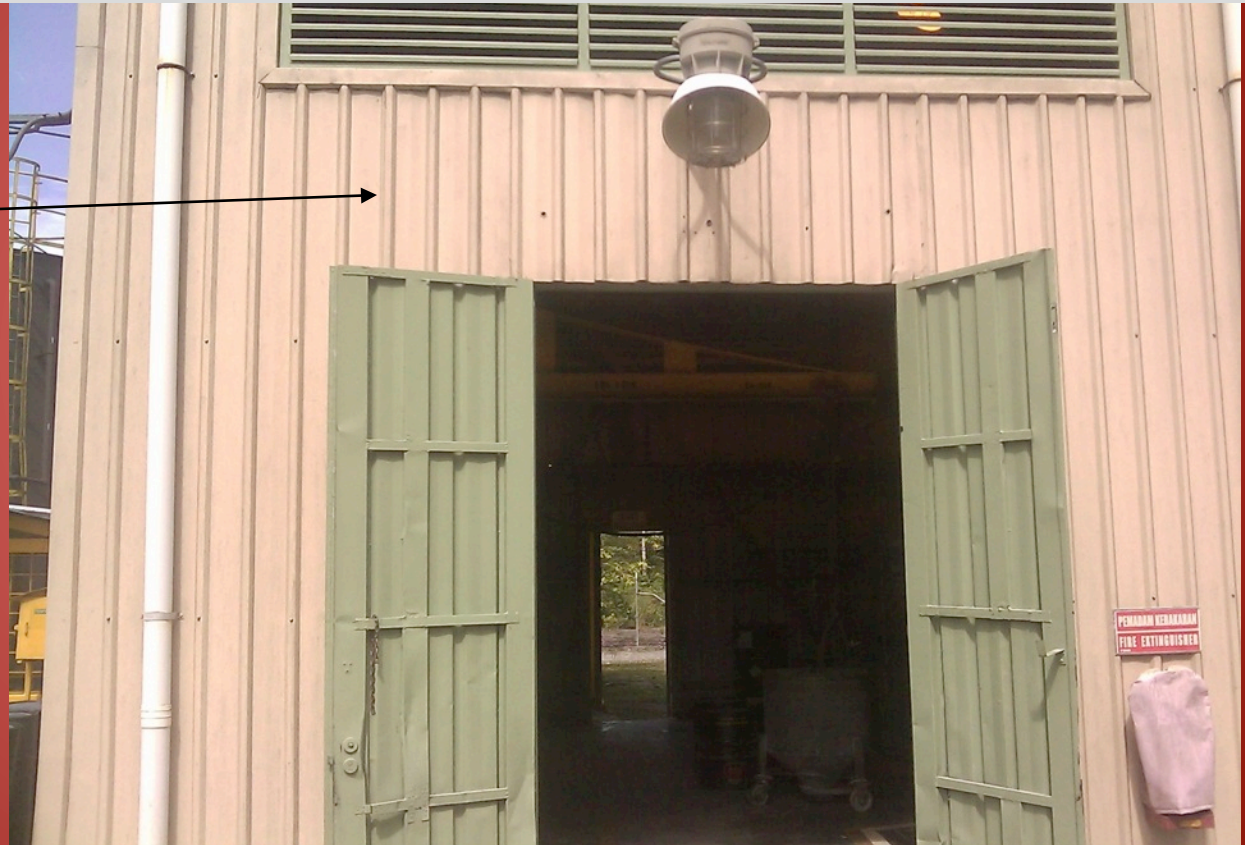
There are no signs warning people that calcium carbide is stored in this area of the building

Post signs stating that this is a calcium carbide storage area and no water is to be used in the area
